AGENDA
DISTRICT OF PORT HARDY
COMMITTEE OF THE WHOLE MEETING
5:45 pm TUESDAY AUGUST 9, 2016
COUNCIL CHAMBERS, MUNICIPAL HALL
7360 COLUMBIA STREET

DATE: July 11, 2016
TO: Mayor and Councillors
FROM: Allison McCarrick, Chief Administrative Officer
RE: Seagate Pier Inspection

**PORT HARDY SEAGATE PIER
INSPECTION REPORT**

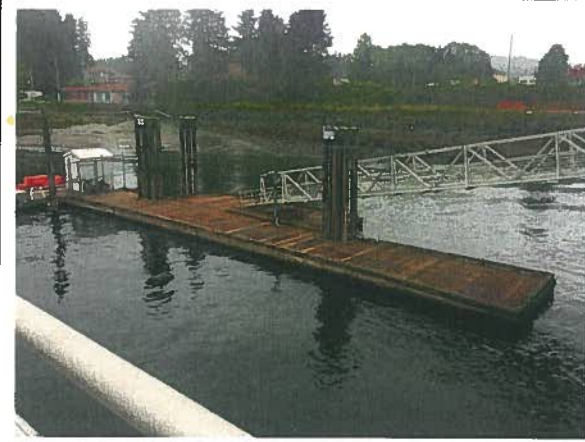
Figure 3.3.1.

Timber floats 1 and 2 were inspected and found to be in generally good condition and require only minor improvements. The Northeastern corner of Float 2 sits low in the water. Other concerns regarding wear occur at the connections between the two floats and around the dolphins that hold float 2 in place.

View of the timber floats from the pier head.

Only minor work is required on the floats. The excess clearance around the dolphins float 2 is secured by should be reduced by building up the inside of their opening with creosote treated timbers to reduce play in both the north/south and east/west directions to 2". The connection between floats 1 and 2 should be reduced to allow for a maximum of 4" of play. The foam billet under the northeast corner should be replaced.

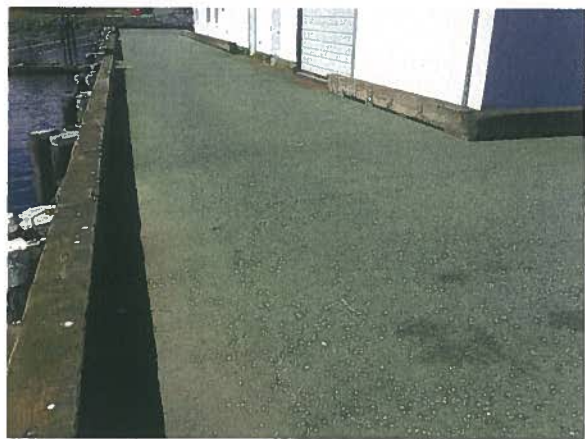
Figure 4.0.1.

The inspection revealed a number of issues with components on both the pier approach and pier head. Miscellaneous issues indirectly affecting pier components included minor cracking of asphalt on the pier approach, significant deterioration of asphalt on pier head (Figure 4.0.1.), lack of lashing around fender pile dolphins, and inadequate lamppost bracing (Figure 4.0.2.).

View of deteriorated asphalt on pier head.

Asphalt sealing is a high priority as it protects all components below the deck. It should be noted that special attention should be paid to the seal around the coast guard building as problems with cap beam rot appear to be a direct result of water ingress around the building. Asphalt sealant is an acceptable medium for repairs to both asphalt cracks and the sealant around the coast guard building.

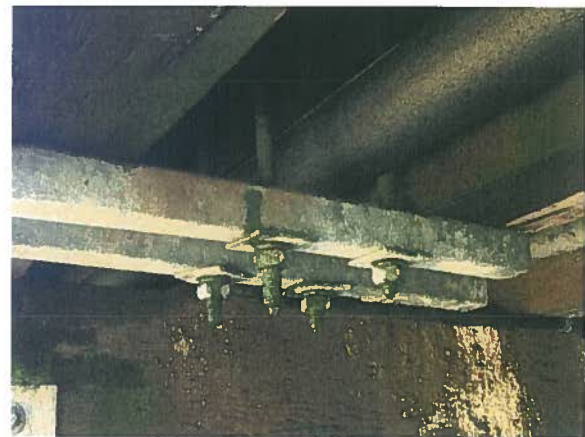
Figure 4.0.2.

View of inadequate bracing that anchors lampposts to pier approach.

The current system used to anchor the lampposts is ineffective. The current C-channel bracing used should be replaced with 10"x20"x1/2" steel plating or 20" long 10" C-channel. If C-channel is used it is important that the flange is facing down when installed. This proposed "C" channel orientation is to prevent the flanges from cutting into the stringers it braces against as the bolts are tightened.

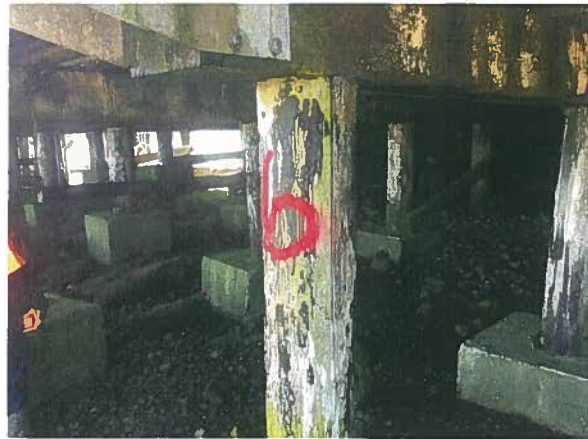
Figure 4.1.1.

In general, the piles are in good condition. The only recurring issues with the bearing piles were splitting and checking, an example of which can be seen in figure 4.1.1. Table 4.1.1 summarizes all issues with piles, concerns associated with individual piles can be seen in (Appendix 4.1.1.) In addition to splitting/checking there was a missing pile, a hollow pile, a loose pile, and a cracked concrete post base.

An example of a typical split post top at post 6A.

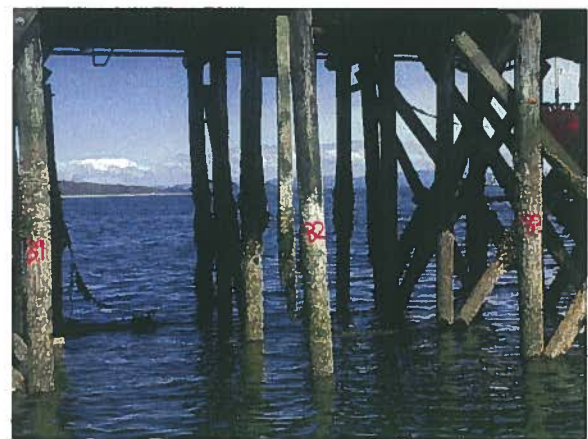
Figure 4.2.1.

Numerous cross/horizontal bracing members were missing bolts (corroded and failed), cracked, or rotten. Table 4.2.1 summarizes all issues with bracing. Appendix 4.2.1 outlines all issues with cross bracing that runs along bents. Appendix 4.2.2 outlines all issues with cross bracing that runs along pile columns. Appendix 4.2.3 outlines all issues with horizontal bracing. An example of broken bracing can be seen in figure 4.2.1.

An example of a typical broken cross brace at pile 32D

Bracing and bolt replacement should occur at the same time as both will require the same tools and may be restricted by tidal access. All bolts at the tops of the batter piles must be replaced. Where deterioration is noted in the batter pile or the vertical pile around the connection, an alternate location for the connection must be found (i.e. the next pile in, or connecting the batter pile to the cap beam). These batter piles are critical to the performance of the pier.

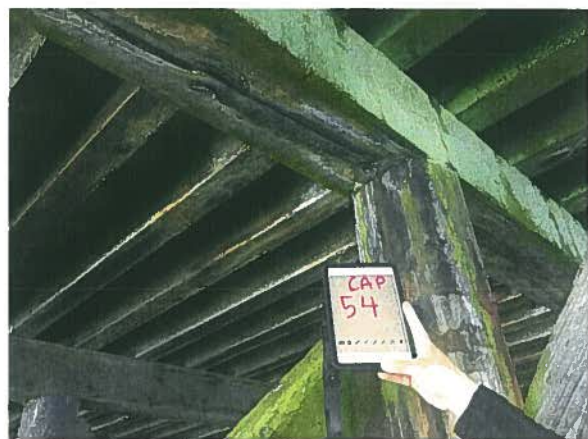
There were 7 problem cap beams identified during the inspection. Issues included crushed ends and rot. Table 4.3.2 outlines all cap beam issues found during the inspection. Figure 4.3.1. shows an example of a rotten cap beam. It should be noted that problem cap beams only occur at exposed ends and at the bents that are at the ends of the building located on the pier head. It is likely that the encountered issues are the result of exposing the caps to excessive moisture/weather.

Cap beam 54 showing signs of rot.

Internal cap beams should be repaired by fishplating identified problem cap beams and the supporting piles the caps rest on. This will allow the stringers to be supported by the fishplate rather than the existing cap beam. The fishplating, banding and stringer replacement program should be implemented at the same time to further utilize the same system.

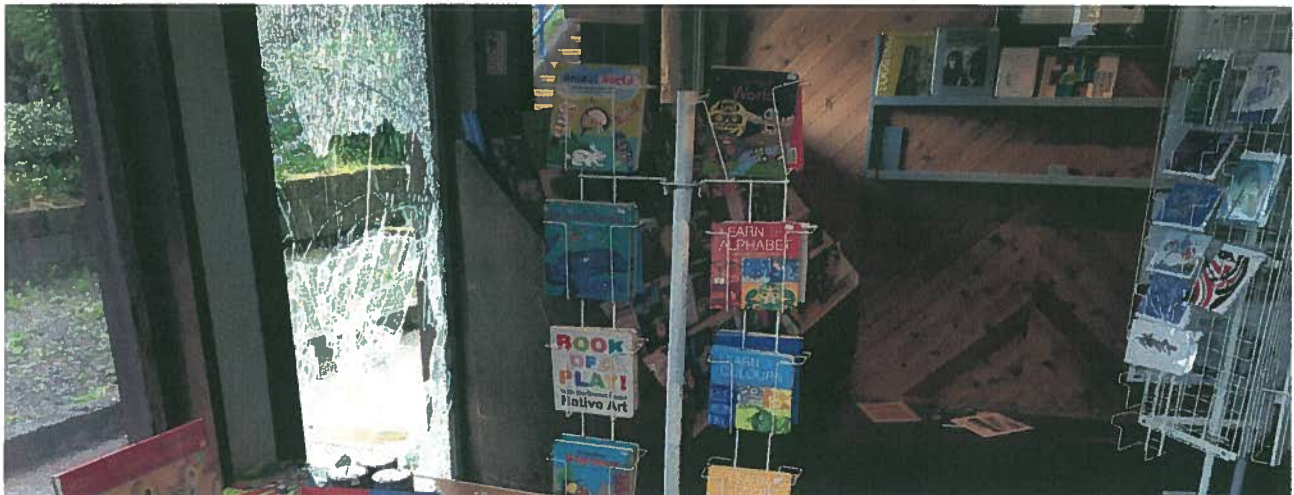
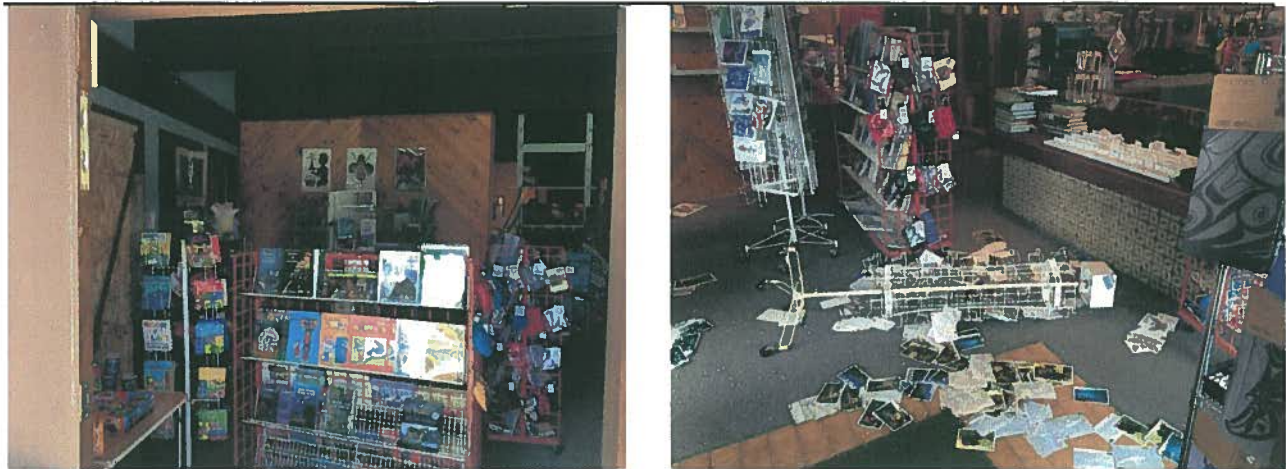
From April of 2016 until July of 2016 the security at the Museum building has been compromised five times. Each time the building, the stands and shelving inside have sustained damage and some valuable items have been stolen. It seems that the gift shop's jewellery display case is the thieves favorite target, so far according to the police report an estimated \$4,000 in Aboriginal jewelry and merchandise have been stolen and at least \$1,000 worth of internal damage have been repaired.

External damages consist of broken windows and other cosmetic damages to the facade of the building. Each act of break and entering has resulted in boarding of the broken windows and eventual replacement of the broken windows. Thus far, without considering staff time, we have spent in a neighbourhood of \$12,000 towards fixing the external damages including approximately \$5,000 for purchase and installation of security cameras.

Staff recommends that Council considers either Option #3 (External Window Shutters) or Option #4 (External Security Bars); for a budget of up to \$30,000. The \$10,000 established in the 2016-2020 Financial Plan for Museum renovations be redirected towards the security project plus additional funds be withdrawn from the Building Reserve Fund.
